RESERVOIR CLEANING AT LA BALME- DE-RENCUREL

La Balme-de-Rencurel

**EDF (Électricité
de France)**

**La Balme-
de-Rencurel (38),
France**

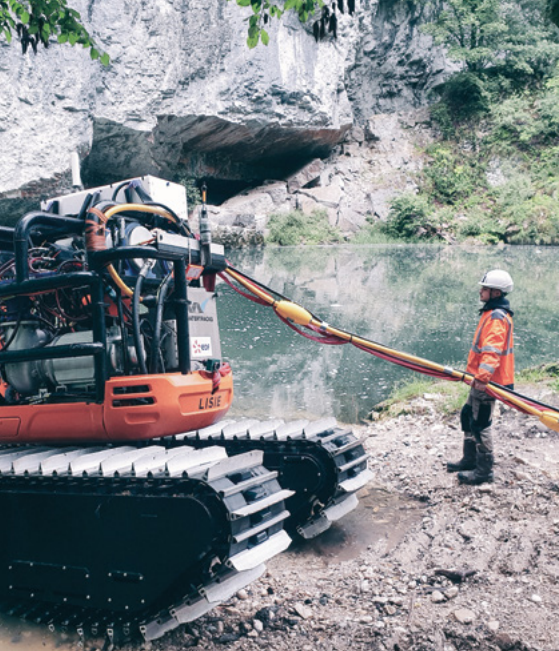
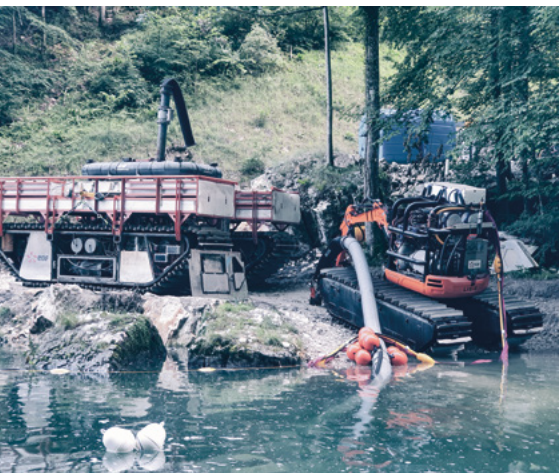
To restore the La Balme-de-Rencurel reservoir, whose access is highly constrained by a narrow road and a steep track at the tail end of the reservoir, Watertracks deployed the NESSIE® underwater robot for the main dredging operation. Sediment discharge was carried out in a controlled manner immediately downstream over the dam crest.

Fine cleaning around the intake and trashrack clearing were performed using the LISIE mini-excavator, equipped with an air-lift suction tool and occasionally assisted by divers for the removal of larger woody debris.
